# EMI Test Report 26082642G8-EMC Rev. N/C

Test Standards: IEC 61000-4-2

**Vine Camera System**

Performed By: **Applus+ Keystone**  
131 Columbus Innerbelt  
New Castle, PA 16101

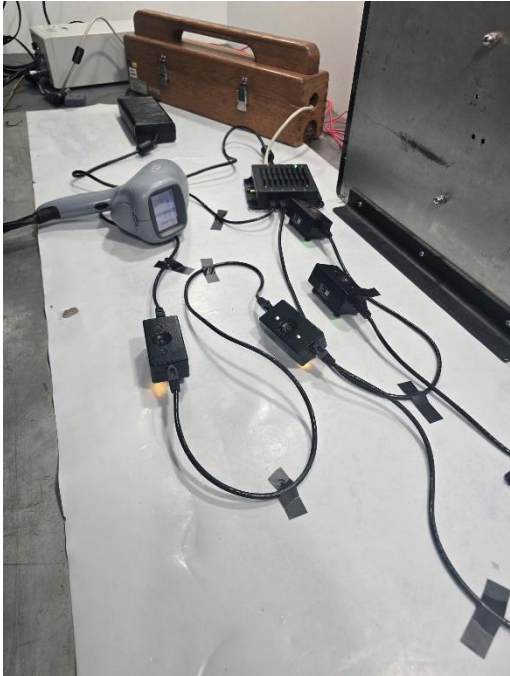
| | <p><b>Electrostatic Discharge Immunity</b></p> <p><b>Test Setup</b></p> |

Using the mode of operation and configuration noted within this report, an Electrostatic Discharge Immunity test was performed to EN 61000-4-2:2008. The EUT was tested using air and contact discharges. The specified number of air discharges was applied to each of the non-conductive surfaces of the EUT as listed in the datasheet. The specified number of contact discharges was applied to each of the conductive surfaces of the EUT as listed in the datasheet. If a response is detected after the discharge, the type of response, discharge level, and location are noted. Testing was conducted with the EUT fully cabled. Discharges were made to the connector shells, not to the individual conductors.

During the performance of the Electrostatic Discharge Immunity test, the Vine Camera System unit was in the Normal mode and powered with PoE/15VDC.

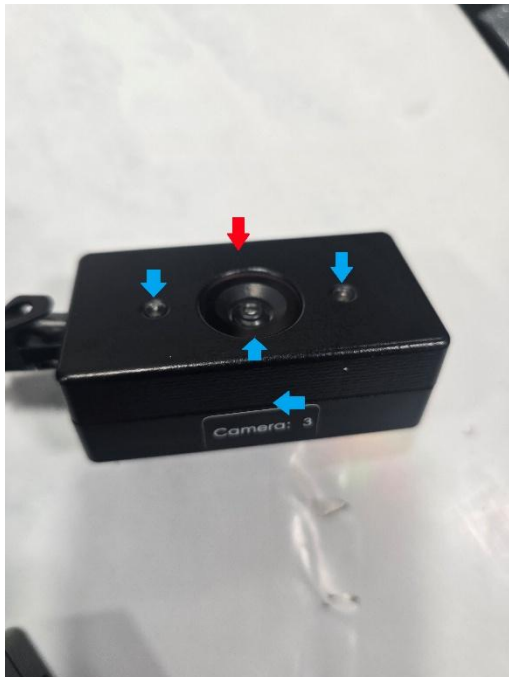
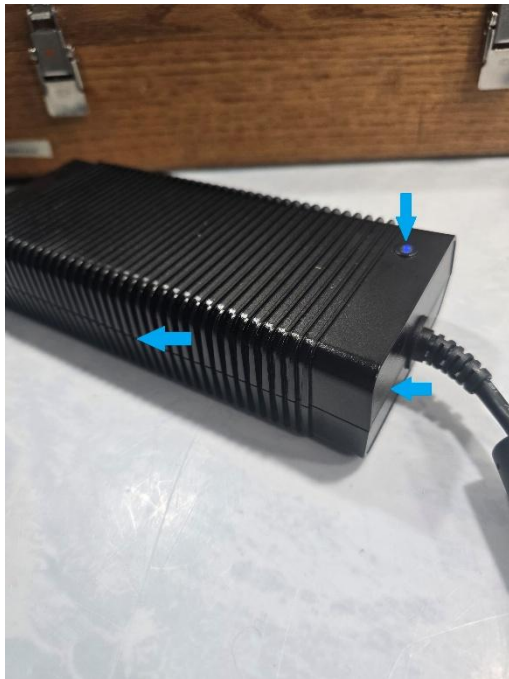
| | <p><b>Electrostatic Discharge Immunity</b></p> <p><b>Test Location</b></p> |

| Air Discharge Data | | | | | | | | | | | |
|---|---|---|---|---|---|---|---|---|---|---|--|
| Camera seam | 1 | 1 | 1 | 1 | 2 | 2 | x | x | 8kV Zapped to Chassis. Cameras froze. Hub needed a power cycle to return to normal operation. all 4 cameras affected. | C | |

| Camera Screws | 1 | 1 | 2 | 2 | x | x | x | x | On cameras 1, 2, and 3 the discharge made the underside leds flash with cameras frozen. The hub needed a power cycle to return to normal operation. | C |
