# EMI Test Report 260826FCA1-EMC Rev. N/C

Test Standards: IEC 61000-4-2

**Tendryl Camera**

Performed By: **Applus+ Keystone**  
131 Columbus Innerbelt  
New Castle, PA 16101

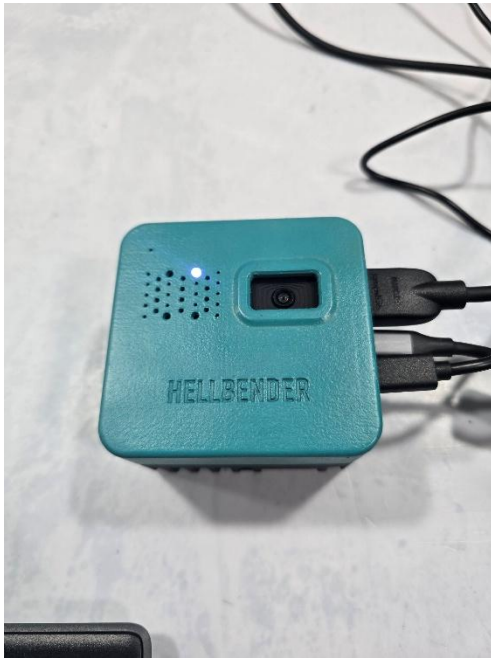
| EUT | |
|---|--|
| <b>Tendryl Camera</b> | |

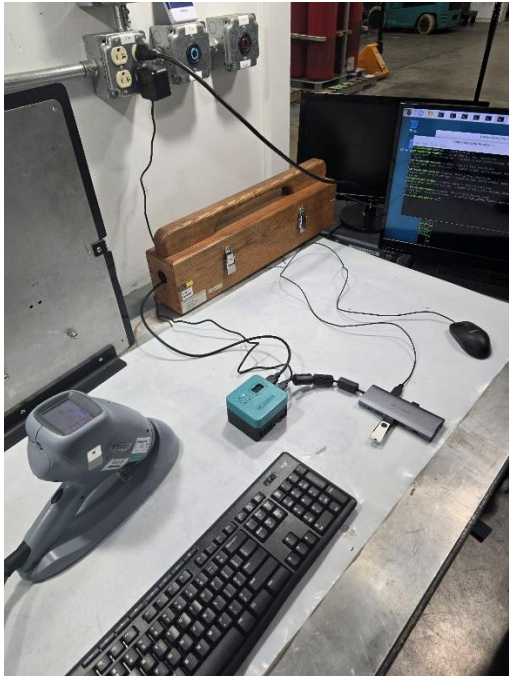
| | <p><b>Electrostatic Discharge Immunity</b></p> <p><b>Test Setup</b></p> |

Using the mode of operation and configuration noted within this report, an Electrostatic Discharge Immunity test was performed to EN 61000-4-2:2008. The EUT was tested using air and contact discharges. The specified number of air discharges was applied to each of the non-conductive surfaces of the EUT as listed in the datasheet. The specified number of contact discharges was applied to each of the conductive surfaces of the EUT as listed in the datasheet. If a response is detected after the discharge, the type of response, discharge level, and location are noted. Testing was conducted with the EUT fully cabled. Discharges were made to the connector shells, not to the individual conductors.

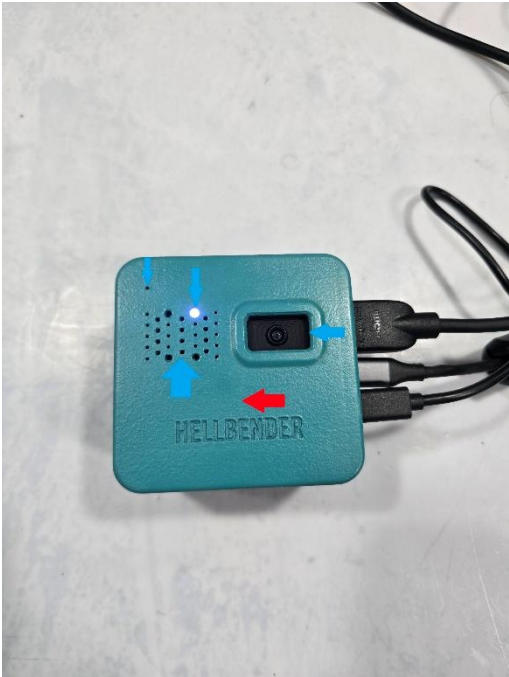
| | <p><b>Electrostatic Discharge Immunity</b></p> <p><b>Test Location</b></p> |

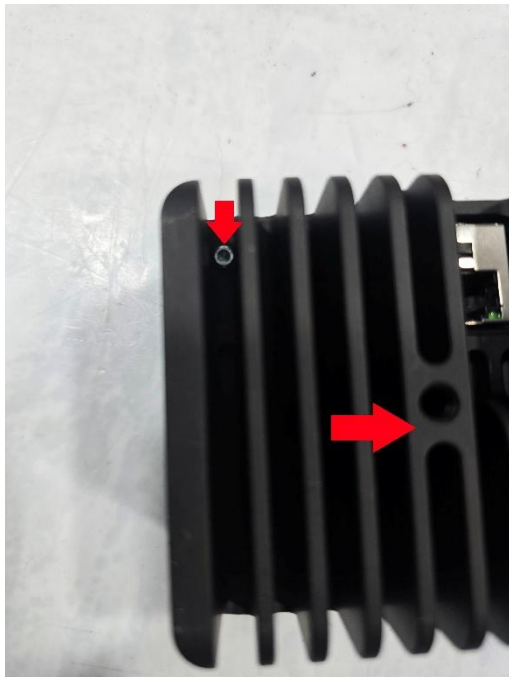
| Electrostatic Discharge Immunity | |
|---|---|
| | Test Location |
